**DEPARTMENT OF TRANSPORTATION****DIVISION OF ENGINEERING SERVICES**

Contract #: 04-0120F4Cty: SF/ALA Rte: 80 PM: 13.2/13.9File #: 99.28**WELDING INSPECTION REPORT****Resident Engineer:**Siegenthaler, Peter**Address:** 333 Burma Road**City:** Oakland, CA 94607**Report No:** WIR-024613**Date Inspected:** 14-Jan-2011**Project Name:** SAS Superstructure**OSM Arrival Time:** 1900**Prime Contractor:** American Bridge/Fluor Enterprises, a JV**OSM Departure Time:** 300**Contractor:** Zhenhua Port Machinery Company, Ltd (ZPMC) Changxing Island **Location:** Shanghai, China**CWI Name:** Ji Cai Fang**CWI Present:** Yes No**Inspected CWI report:** Yes No N/A**Rod Oven in Use:** Yes No N/A**Electrode to specification:** Yes No N/A**Weld Procedures Followed:** Yes No N/A**Qualified Welders:** Yes No N/A**Verified Joint Fit-up:** Yes No N/A**Approved Drawings:** Yes No N/A**Approved WPS:** Yes No N/A**Delayed / Cancelled:** Yes No N/A**Bridge No:** 34-0006**Component:** OBG**Summary of Items Observed:**

**WELDING**

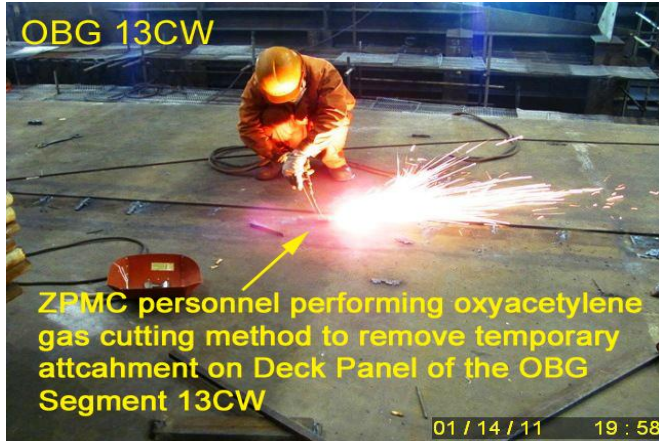
During random in process observations of OBG Segment 13CW, this QA inspector observed ZPMC personnel performing oxyacetylene gas cutting method to remove temporary attachment on deck panel of the OBG Segment 13CW. This QA performed Visual Testing (VT) of the Deck Panel and found they appeared to be in general compliance with the applicable contract documents. See Photo "A".
